**Leapmotor C10**  
Standard Safety Equipment

2024

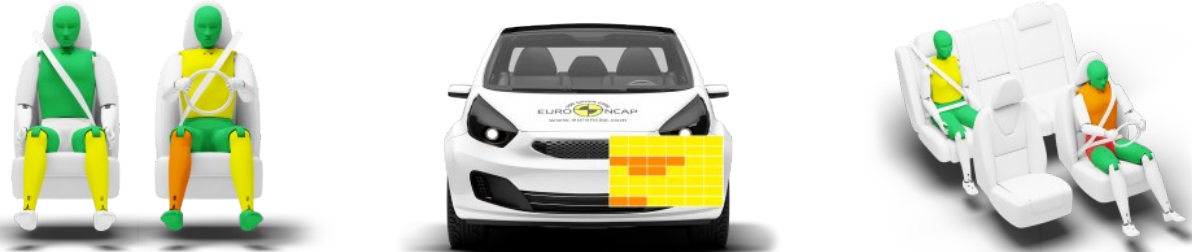
Frontal Impact 13.0 / 16 Pts

Mobile Progressive Deformable Barrier      Full Width Rigid Barrier

The passenger compartment of the Leapmotor C10 remained stable in the frontal offset test. Dummy readings indicated good protection of the knees and femurs for the driver and front passenger. Leapmotor demonstrated that a similar level of protection would be provided to occupants of different sizes and to those sitting in different positions. Analysis of the deceleration of the impact trolley during the test, and analysis of the deformable barrier after the test, revealed that the Leapmotor C10 would be a benign impact partner in a frontal collision. In the full-width rigid barrier test, protection of the driver's chest was marginal but that of all other critical body regions was good or adequate, both for the driver and the rear passenger. In both the side barrier test and the more severe side pole impact, full points were scored, with good protection of all critical body regions. Control of excursion (the extent to which a body is thrown to the other side of the vehicle when it is hit from the far side) was found to be adequate. The Leapmotor C10 has a countermeasure to mitigate against occupant-to-occupant injuries in such impacts. The airbag performed well in Euro NCAP's tests with dummy readings indicating good protection for both the driver and passenger. Tests on the front seats and head restraints demonstrated good protection against whiplash injuries in the event of a rear-end collision. A geometric analysis of the rear seats also indicated good whiplash protection. The car has an advanced eCall system which alerts the emergency services in the event of a crash, and a system to prevent secondary impacts after the car has been in a collision. Leapmotor demonstrated that the doors and windows would be openable to allow occupants to escape in the event of vehicle submergence.

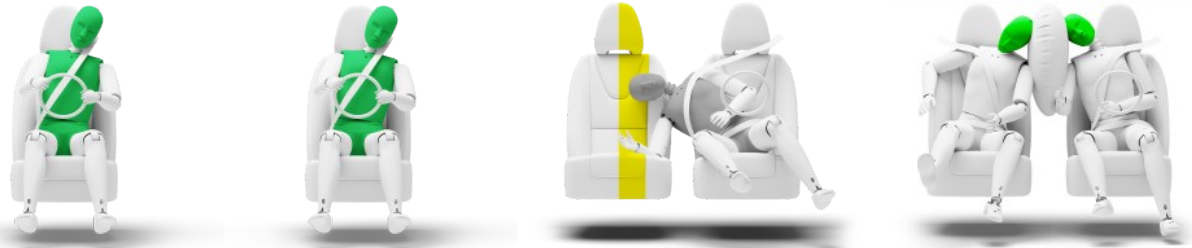
Lateral Impact 16.0 / 16 Pts

Side Mobile Barrier      Side Pole      Far-Side Excursion      Occupant Interaction
